Appendix A

A. Rehabilitation of Mechanical Systems At Wells, Pump Stations And Pipelines

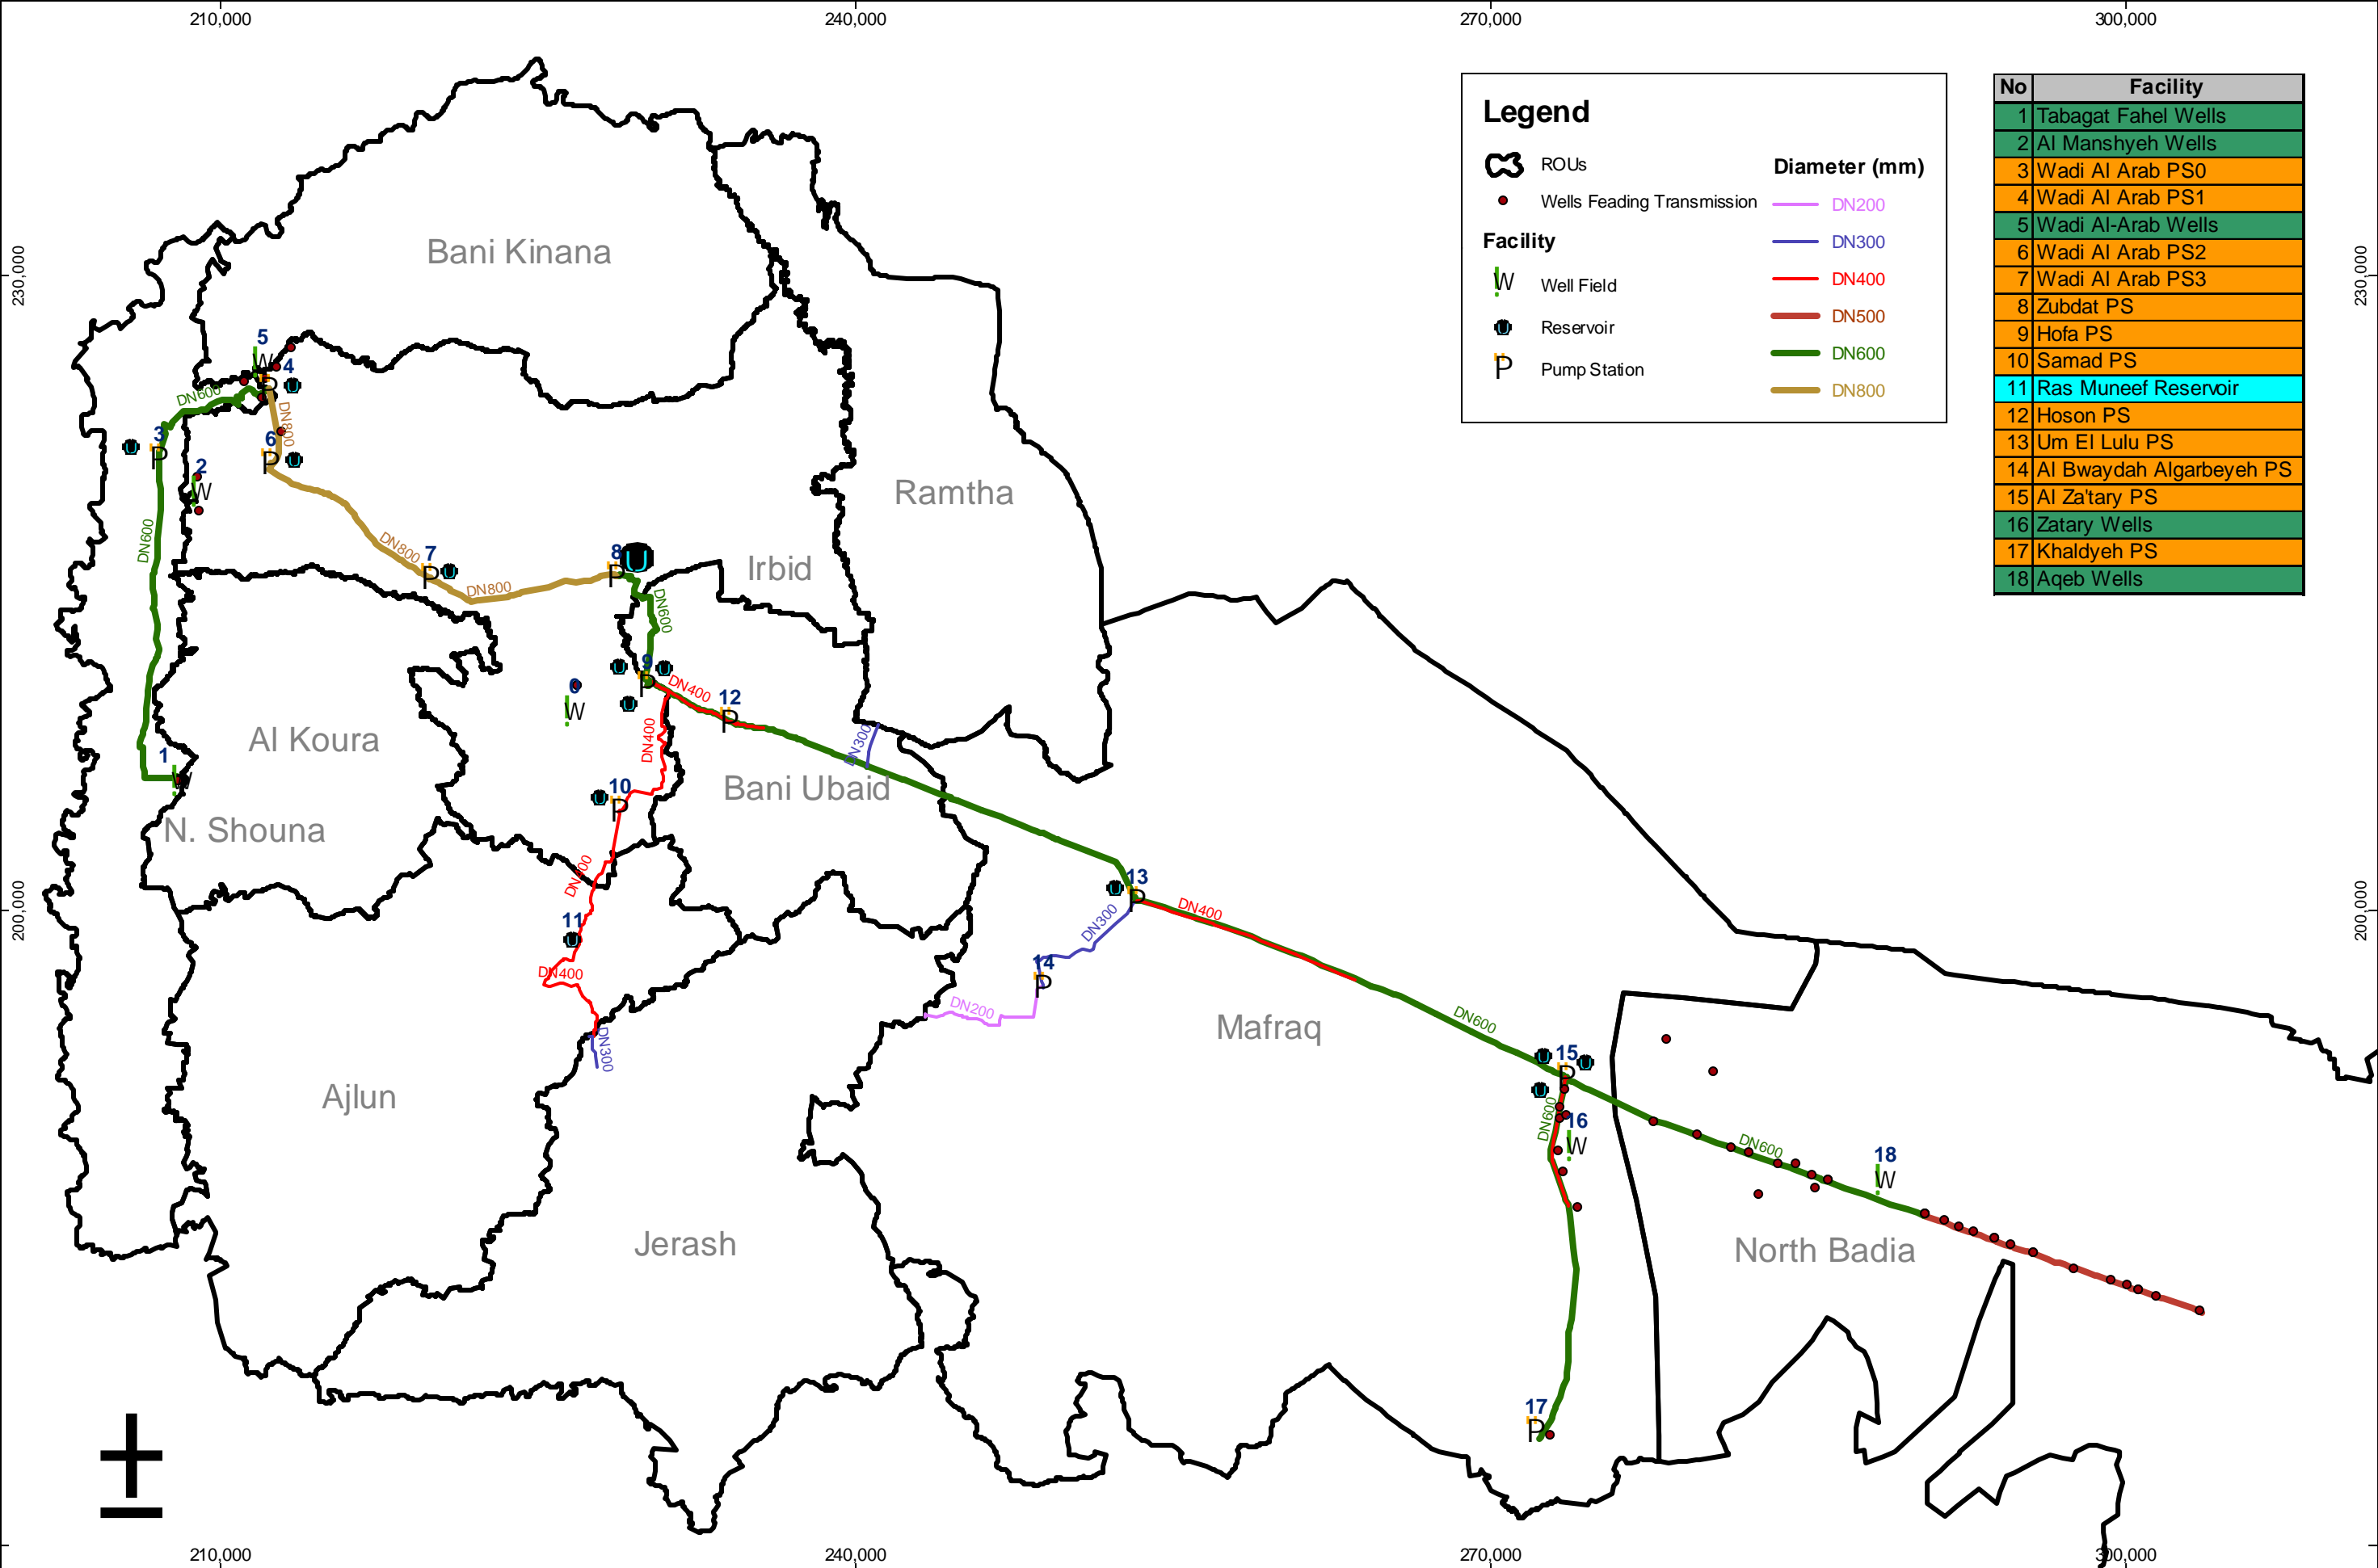
Location	Pipeline	Status of Pipeline	Valves
East Transmission System	Aqeb - Zatory line, 32 km length	Acceptable condition; repairs needed	New Valves
	Zatory - Hofa line, 48 km length	Acceptable condition; limit of 200m head at Zatory PS	New Valves
	Zatory - Khaldyeh line	Good Condition	New Valves
	Branch lines from wells to transmission mains	Replacement recommended	
West Transmission System	Line from Tabaqat Fahel to Wadi Arab PS0	Excellent Condition	Maintenance
	Line from Wadi Arab PS0 to PS1	Excellent Condition	Maintenance
	Line from Wadi Arab PS1 to Zubdat reservoir	Excellent Condition	Maintenance
	Pipeline from Zubdat to Hofa	Excellent Condition	Maintenance
	Branch lines from wells to transmission mains	Replacement recommended
